Gully Stabilisation & Soil Conservation

Cooperation - the key to future flooding resilience

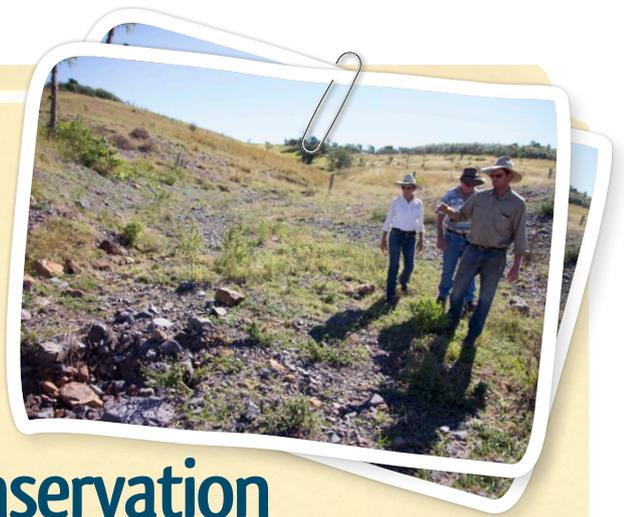
The worst problem was the deep erosion chasm formed at a boundary fence that would continue to worsen, and cause more erosion down the sides of the gully in Mr Hanrahan's property in every future high rainfall event.

A 6 metre-deep erosion chasm caused by flooding in Ex-Tropical Cyclone Oswald in 2013 had impacts on more than one property.

By repairing the erosion chasm, the boundary fence has been re-erected in its correct location and stock on the adjoining property can cross it safely.

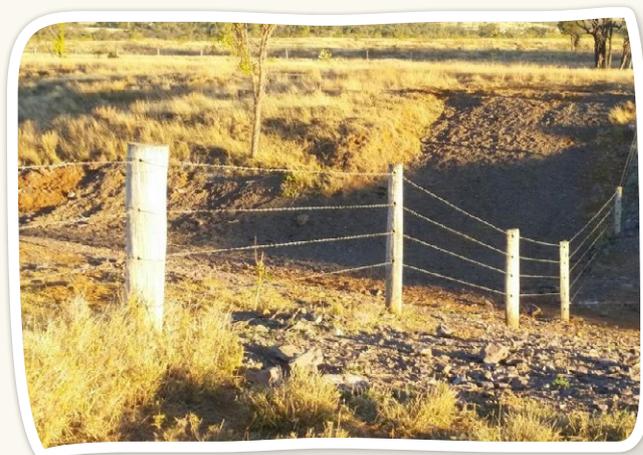
A rock chute, constructed by landholders working together and with help from FBA, was so effective in addressing the problem that it withstood the impacts from Severe Tropical Cyclone Marcia in February 2015, with no erosion occurring at all.

The biggest result of the project is that erosion from the gully has ceased, ensuring a huge reduction in sediment flowing from the property to the Great Barrier Reef. As the water travels over the chute, it slows down, thus reducing its erosive force.

- no erosion at the rock chute and therefore no impact on the boundary fence
- nil wash in the cultivation paddock

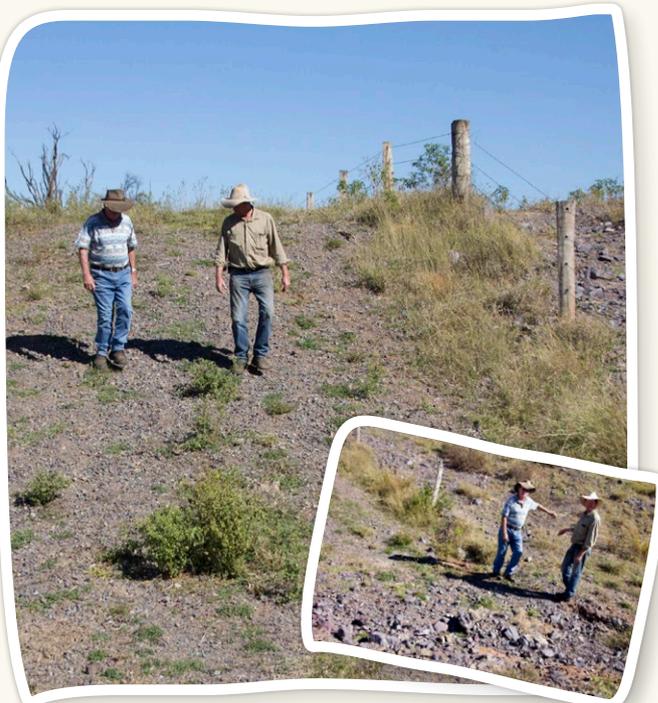
No more erosion - a fantastic result
