Raglan Station — Fitzroy

Gully Erosion

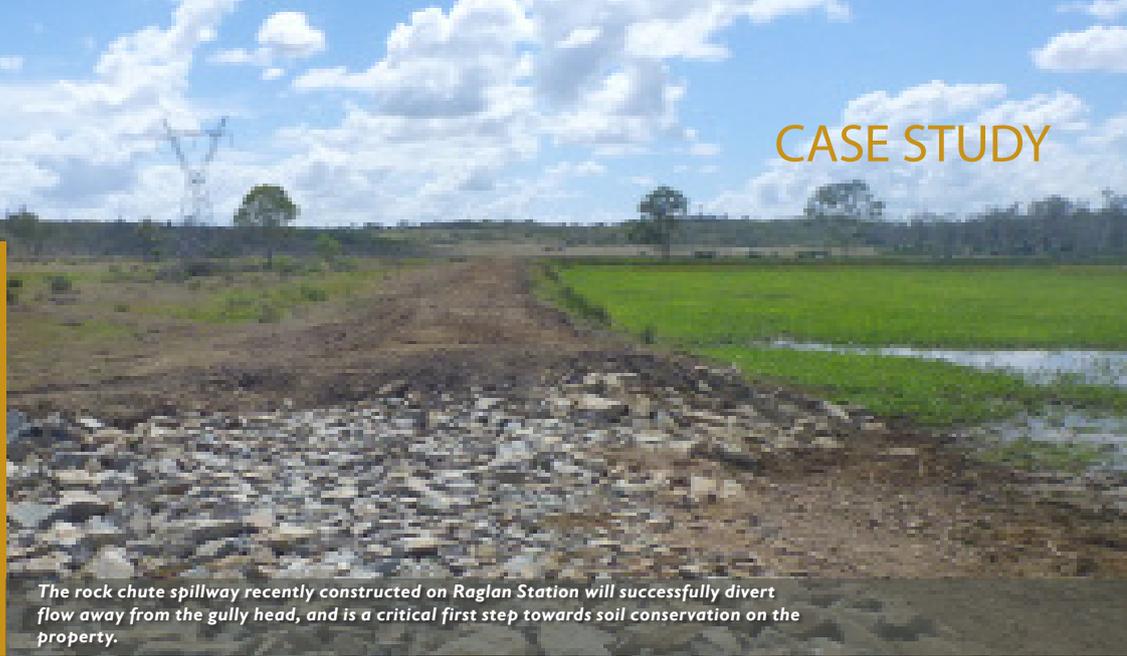
The rock chute spillway recently constructed on Raglan Station will successfully divert flow away from the gully head, and is a critical first step towards soil conservation on the property.

The rock chute spillway and the earthen bund are designed to ensure that any flow exiting the ponded pasture will travel via the spillway, and not via the gully head. According to engineers, the newly installed rock chute is designed to handle flow rates up to and including a 1-in-50 year rainfall event. Without the chute and bund wall in place, runoff enters the gully at a rate seven times faster - triggering significant erosion as a result.

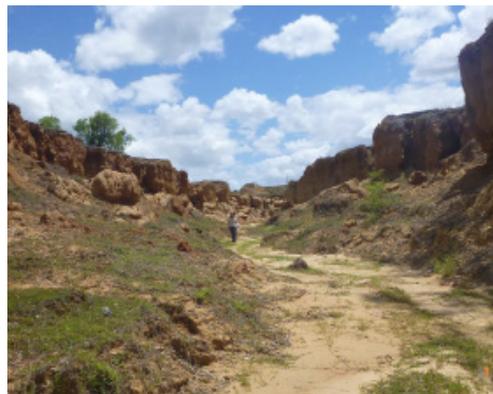
LEFT - A highly erosive gully was present on the property, measuring depths of up to 10 metres and widths of up to 20 metres in some areas.

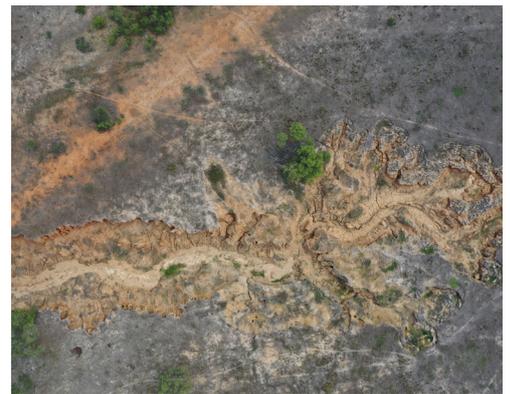
RIGHT - The gully from above

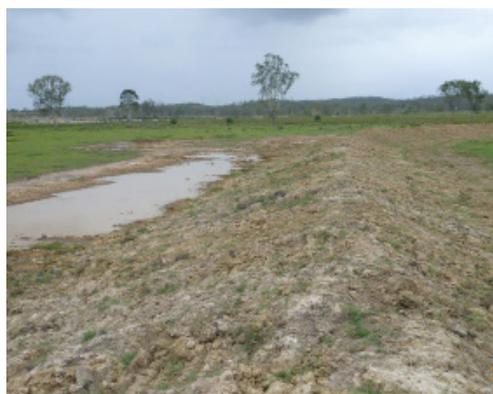
LEFT - The earthen bund wall is designed to prevent overflow from the ponded pasture into the gully head.

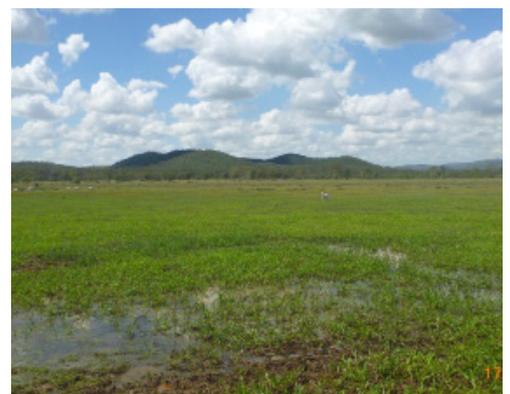
RIGHT - The ponded pasture which has retreated over a decade approximately 1.4 hectares due to gully erosion.

Hollybrook paddock, stocked with 180 Brahman stud cattle, extends both sides of Raglan Creek. The ponded pasture in this paddock was installed over 30 years ago, initially covering an area of approximately 3.8 hectares. This has reduced dramatically over the past decade to around 2.4 hectares due to the incised gully. During times of flood, the gully advanced rapidly cutting into the extensive floodplain, so the potential for ongoing accelerated erosion was high. The landholder, Ryan Olive, conceded erosion had visibly reduced his ponded pastures, and was cutting into productive grazing land. Ryan recognises the need to improve grazing land management, through resting paddocks and fencing off creeks.
